01 / OVERVIEW

A real residential example

Residential 54-point evaluation

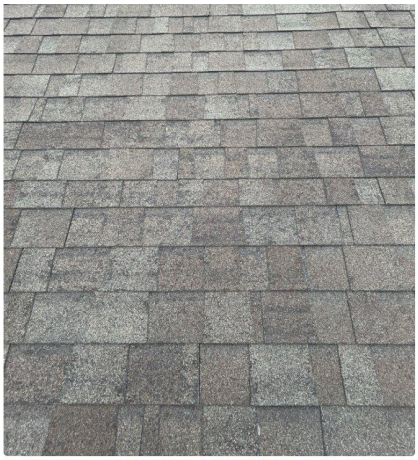
Other components

No chimney, skylights or gutters were recorded. No roof-mounted exhaust ventilation was observed.

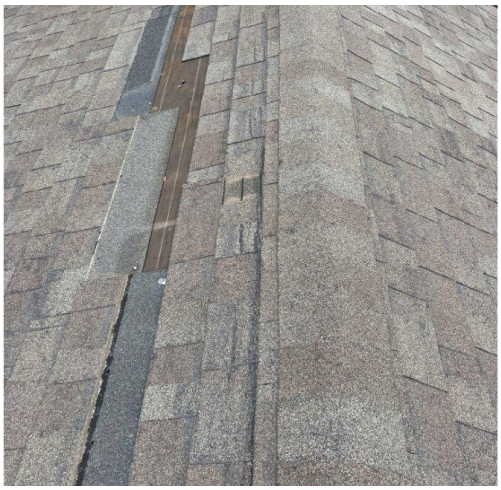
01 / SHINGLE SURFACE

Close-up of the shingle surface. The source report records heavy granule loss and advanced wear.

The original report recommended full roof replacement after documenting advanced wear and wind or hail damage across the evaluated slopes. This recommendation concerns that property and does not mean every storm-damaged roof requires replacement.
